Eastland Port Twin Berths Project Little Penguin/ Kororā (*Eudyptula minor*) Assessment of Ecological Effects

For Eastland Port

August 2022

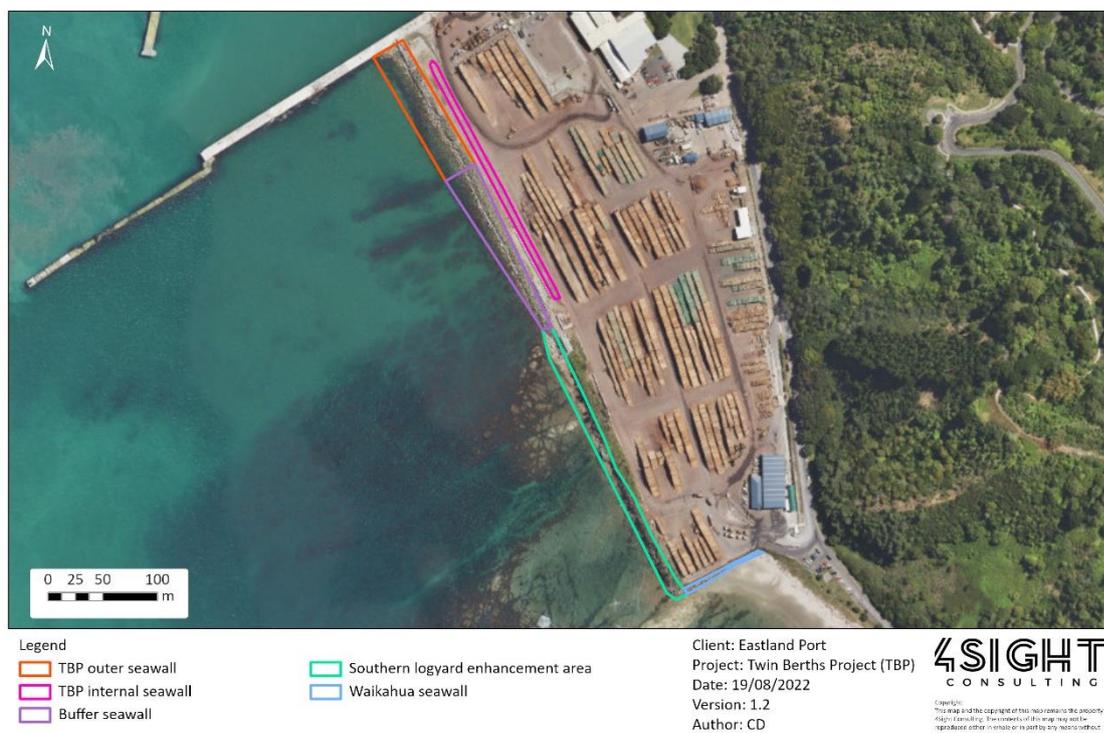
Figure 2: Site overview of the southern seawall to the Southern log yard.

The southern log yard was established on reclaimed land in the 1990s and covers an area of approximately 6.7 ha. Its seaward side is protected by a seawall approximately 550 m long. In 2021, the southern half of the seawall was reconstructed as part of the Seawall Maintenance Project (Figure 2). Presently, the northern 25% of the seawall which will be encapsulated in the proposed reclamation comprises mostly large rock spalls and concrete units (Figure 3). The southern seawall can be divided into the following sections for clarity (Figure 2):

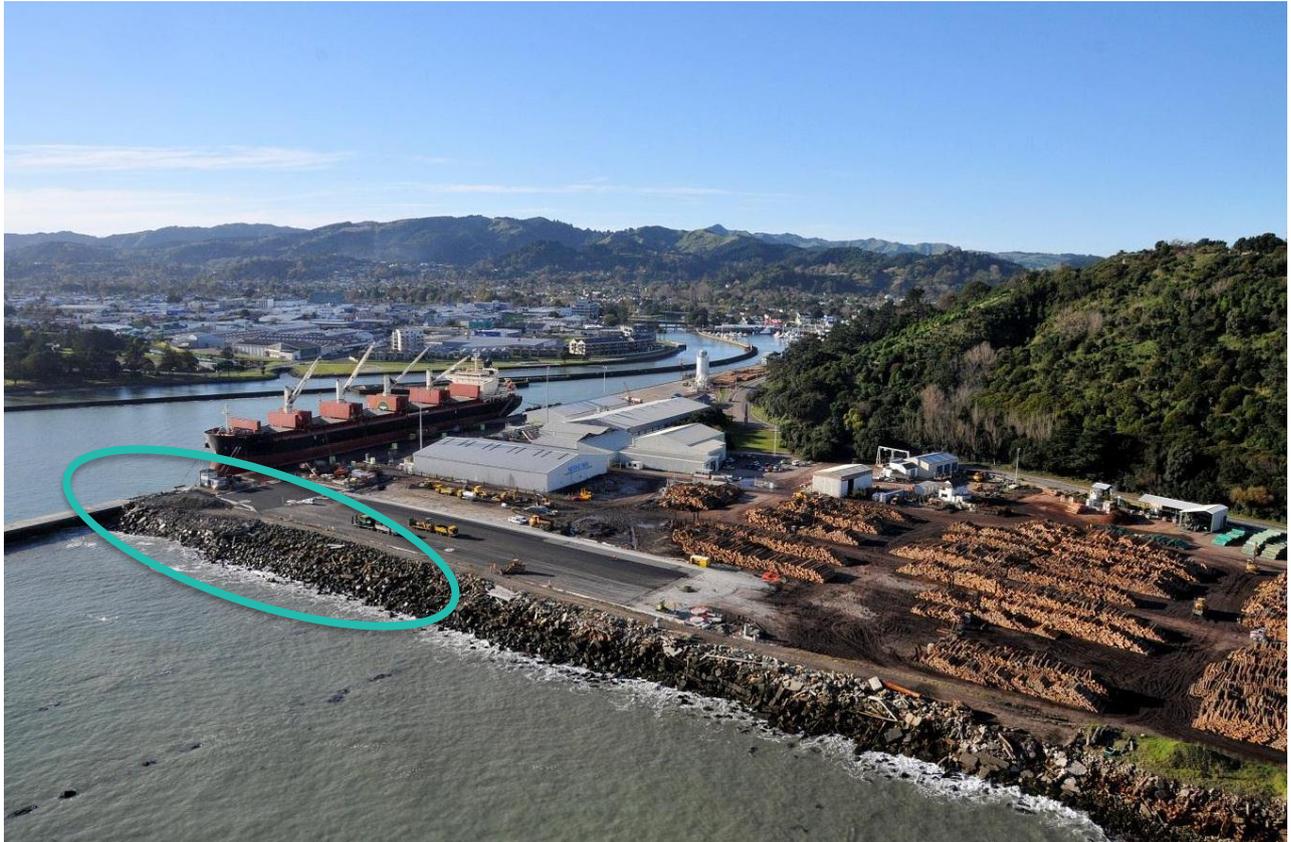
Figure 3: The southern seawall at Eastland Port, looking north towards the Southern Logyard and Gisborne central business district. The area of circled in teal is approximately 130 m of the seawall to be deconstructed as part of the Twin Berths Project (TBP).

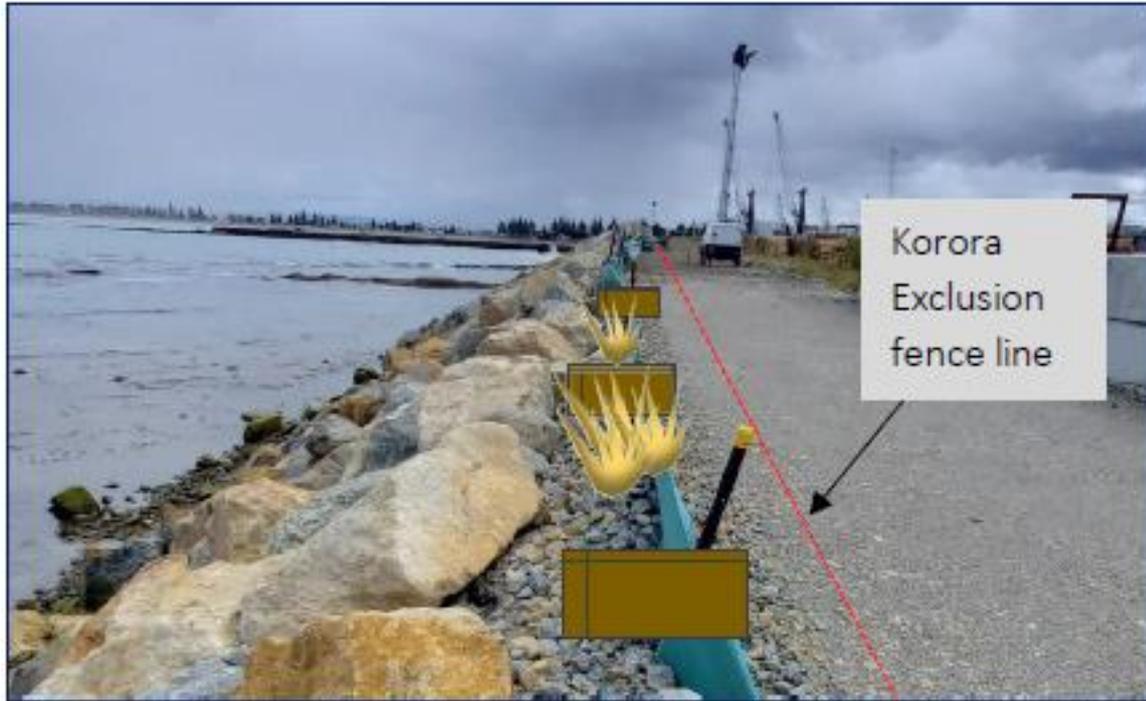
Figure 4: Southern Log Yard Enhancement Area showing indicative nest boxes and Kororā exclusion fence (Source: KCMP Ecoworks 2022).

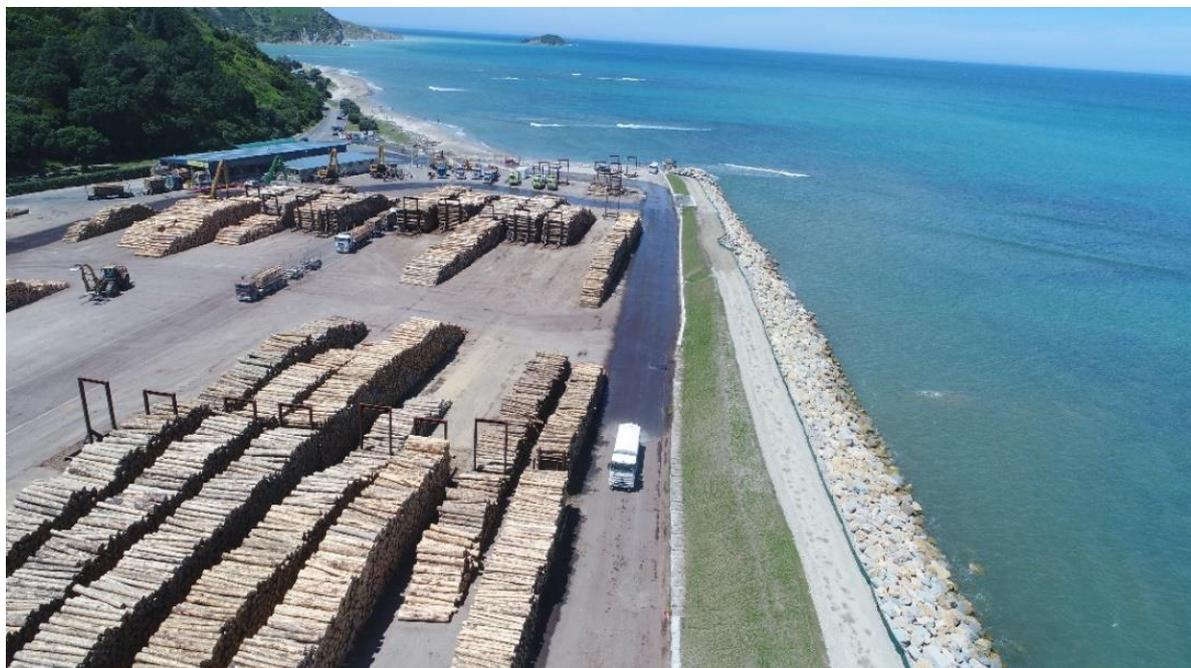
Figure 5: Southern seawall area following reconstruction as part of the Southern Log Yard Seawall Enhancement Project.

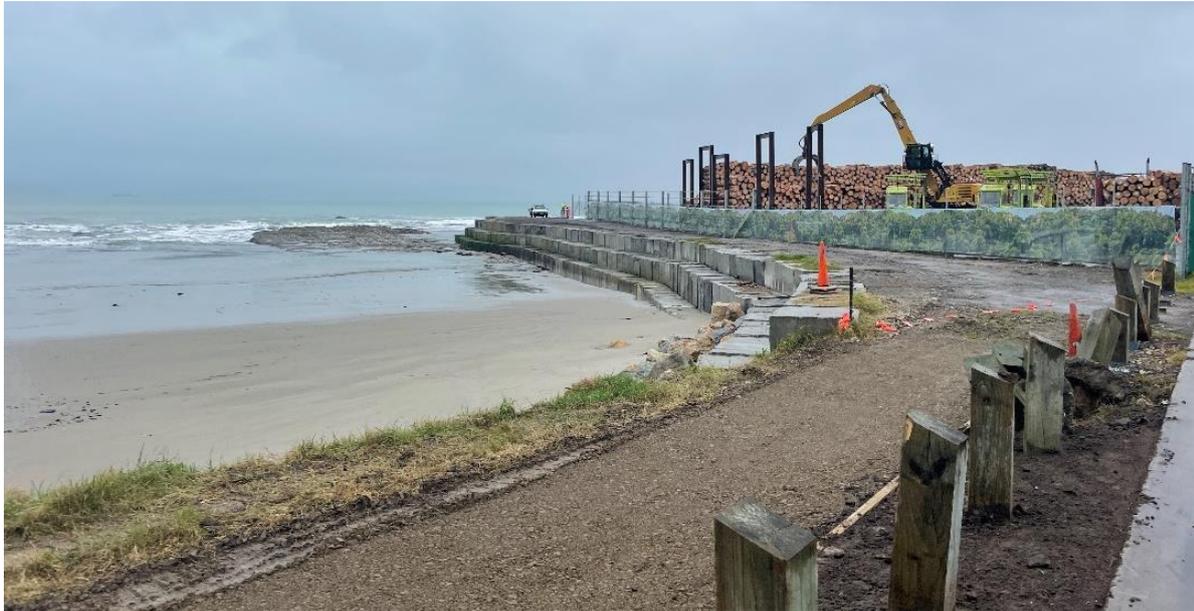
Figure 6: Kaiti Beach and the completed Waikahua seawall.

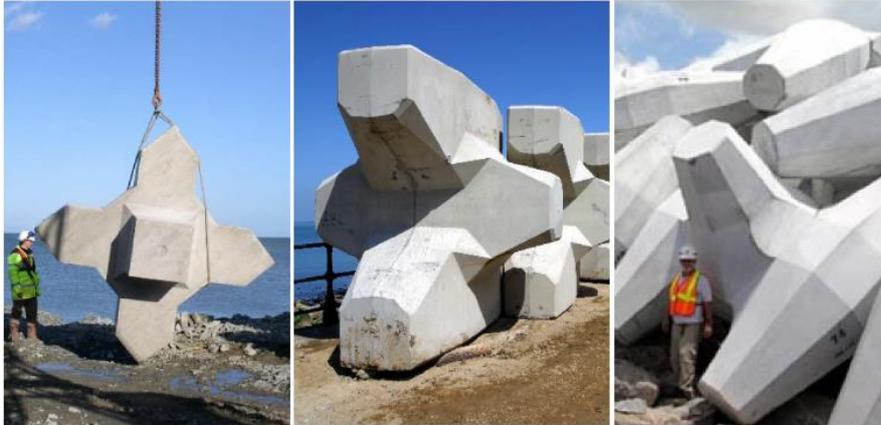
Figure 3-5 – Left – X-bloc® (4 m³/9.6 t, Port Oriel, Ireland). Centre – Accropode units (6.2 m³/14.9 t, Scarborough UK). Right – Core-loc® (15 m³/36 t, Kaunapali Harbor, Hawaii). (Reedjik & Muttray, 2009)

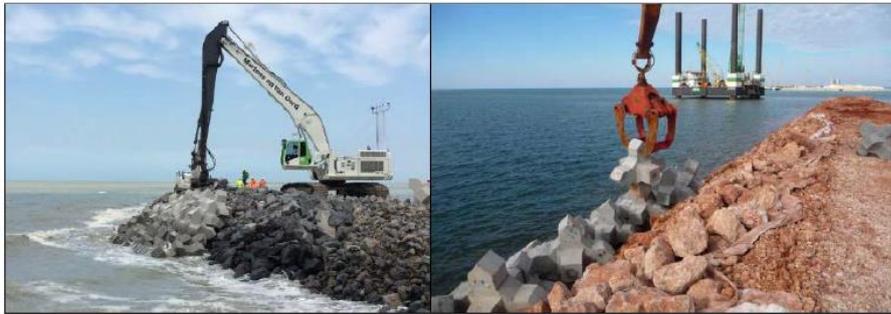
Figure 3-6 – Examples of typical random placement of X-bloc® units

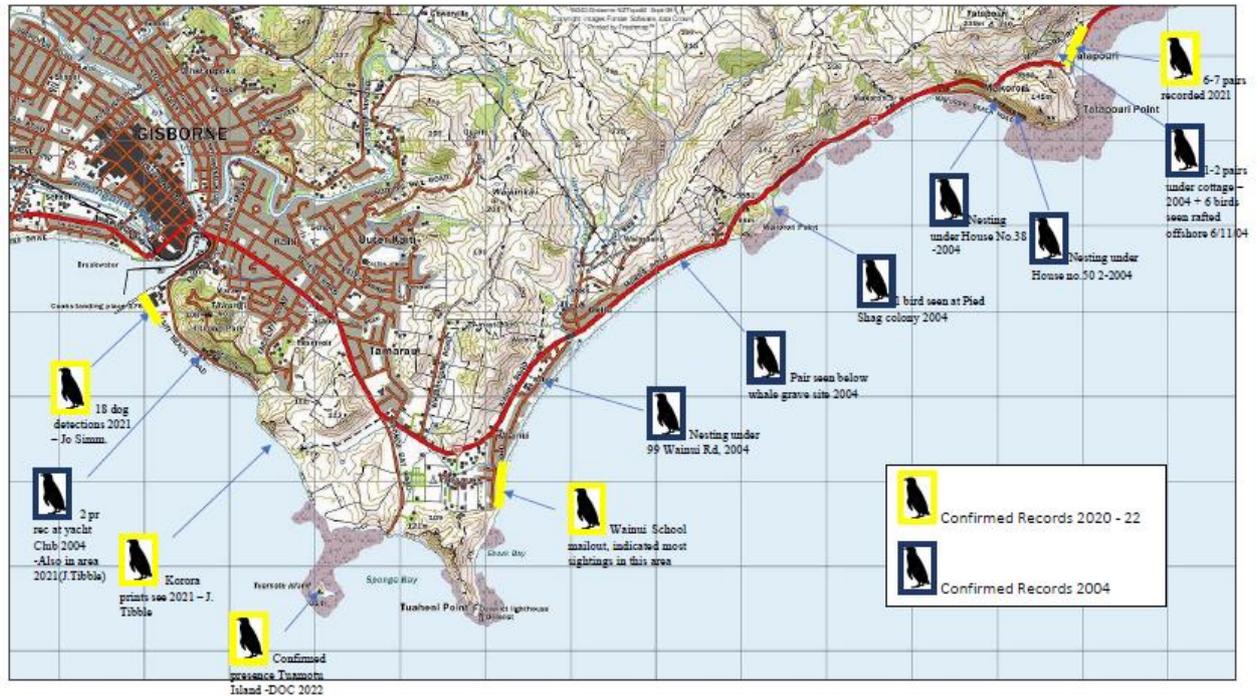
Figure 8: Presence of kororā within the Poverty Bay/Wainui Beach coastal environment (Graphic source: Ecoworks, March 2022).

There is documented presence of kororā within the Poverty Bay coastal environment from the citizen science databases (eBird and iNaturalist), community and news articles online (Figure 8). Community and school projects for nest boxes, signage, and other local initiatives for advocacy of the protection of kororā demonstrates known nesting areas on Wainui and the Tatapouri coast⁴.

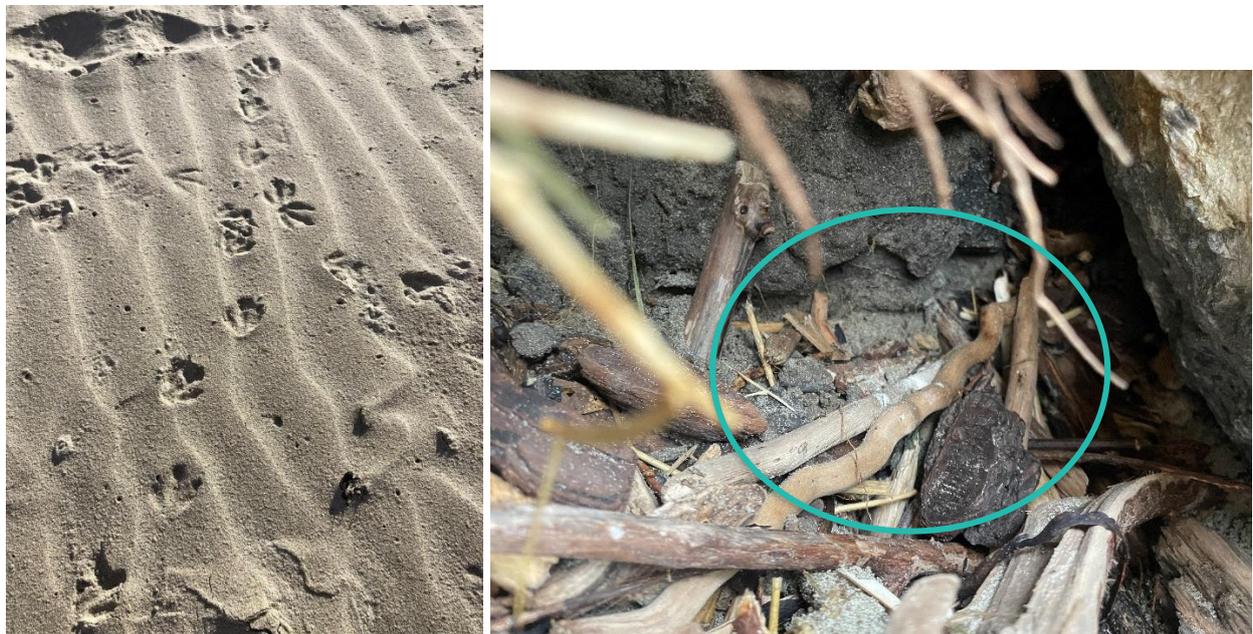
Figure 9: Observations from iNaturalistNZ of kororā footprints⁷ and kororā guano observed on 4Sight site visit on Kaiti Beach in July 2022.

A search of iNaturalist supports our knowledge of the presence of kororā on Kaiti Beach and within the outer seawall that will be deconstructed as part of the TBP (Figure 9 and location shown on Figure 10). An eBird observation from 2019 records a group of seven individuals floating together (rafting) offshore west of Tuamotu Island in Poverty Bay (30/04/19, from Sponge Bay⁶).

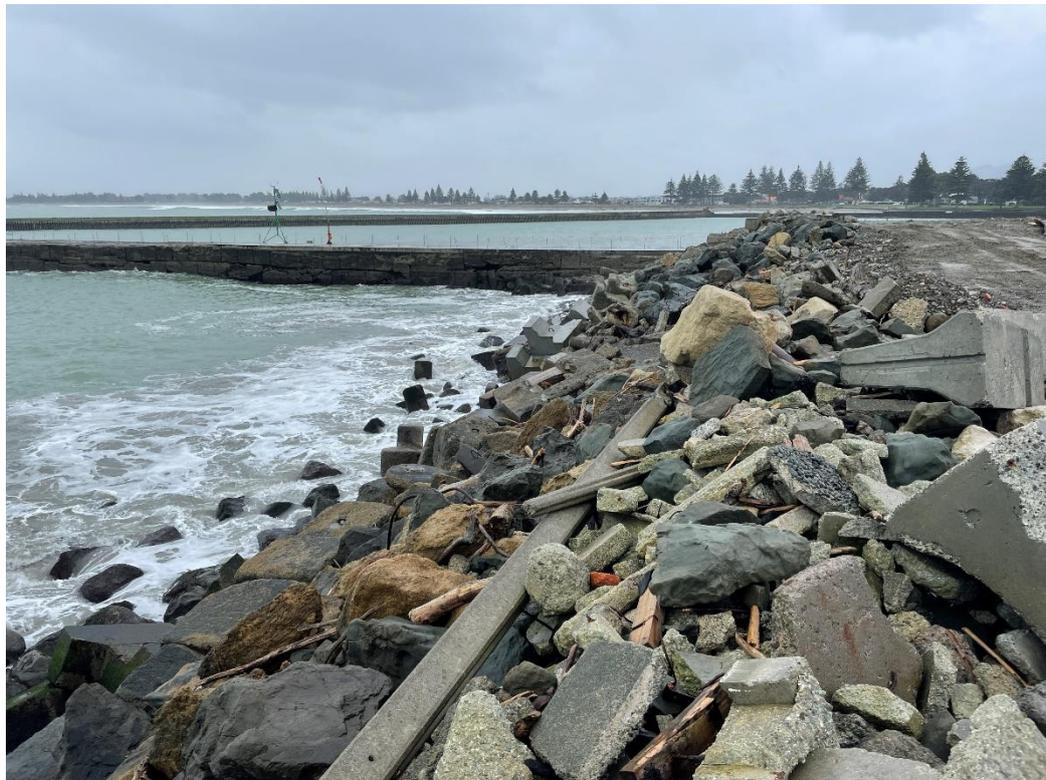
Figure 11: The seawall within the TBP reclamation area is exposed to sea swell and is dominated by large rock spalls and concrete.

The 130 m of outer seawall within the TBP construction footprint is constructed from a mixture of informal concrete blocks, riprap, and rebar (Figure 11). Sections of the existing seawall have failed and areas of the rock wall below MHS were exposed to swell at the time of the July 2022 site visit (Figure 11 and Figure 14). There is a gradient of wave exposure which increases towards and is greatest along the TBP section of the seawall, as the rest of the seawall is protected to some extent by the Kaiti Reef (Figure 13).

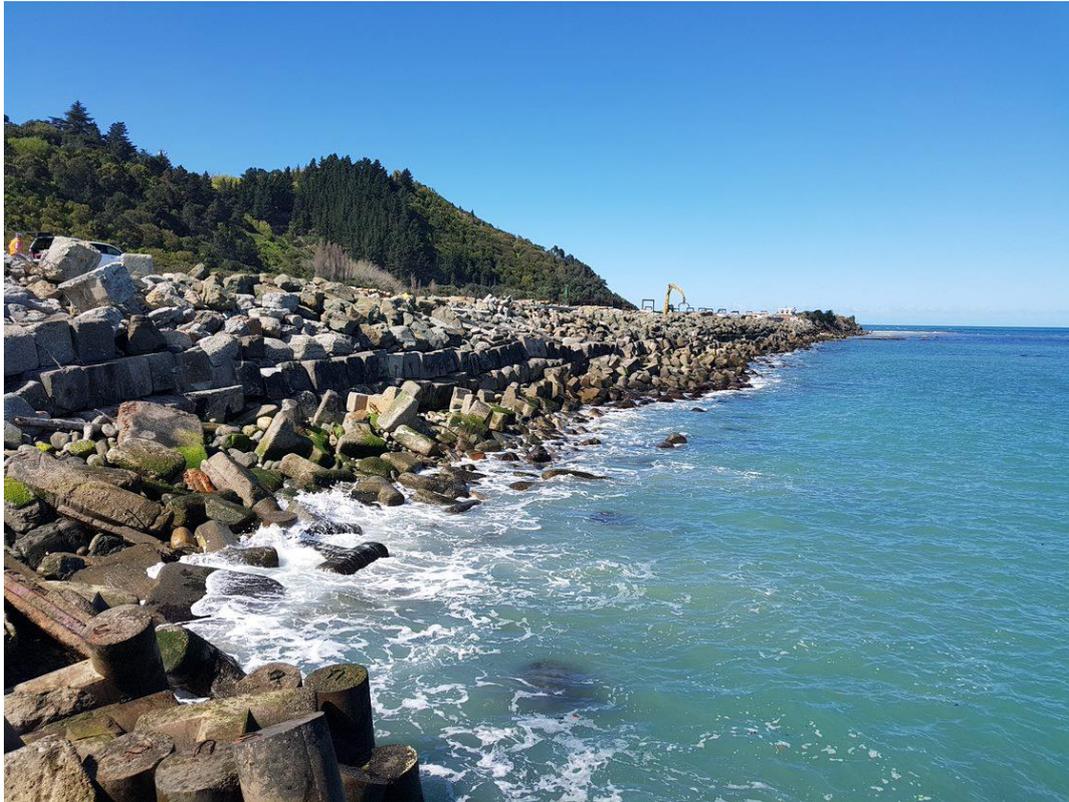
Figure 12: Southern seawall including area affected by the Twin Berths Project.

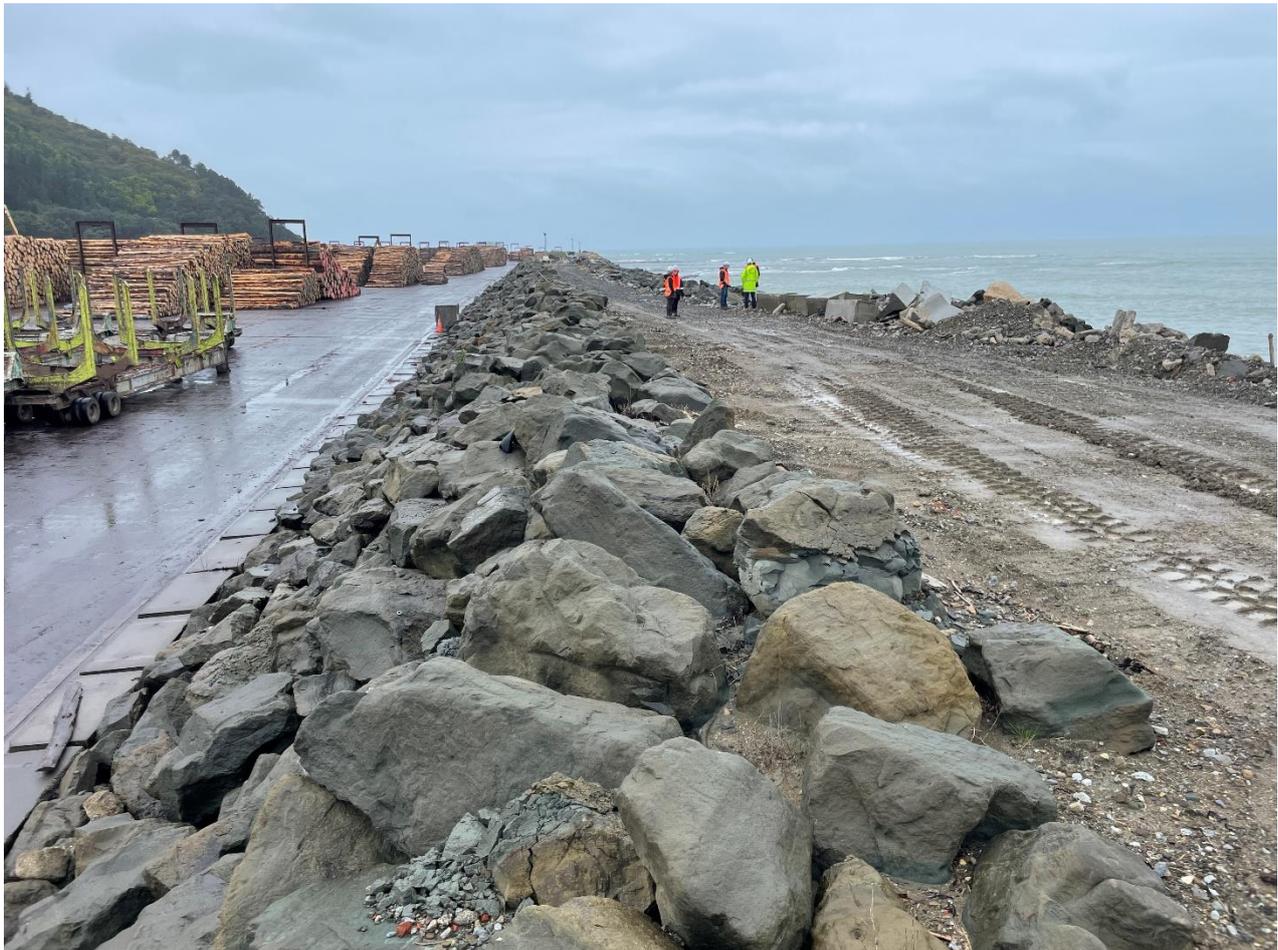
Figure 14: Inner seawall that separates the logyard from the road and the outer seawall.

Given the findings above, it is considered that this section of seawall is of **Low** ecological value. If monitoring surveys of this area were to find active burrows this area, then the ecological value would be **Moderate**.

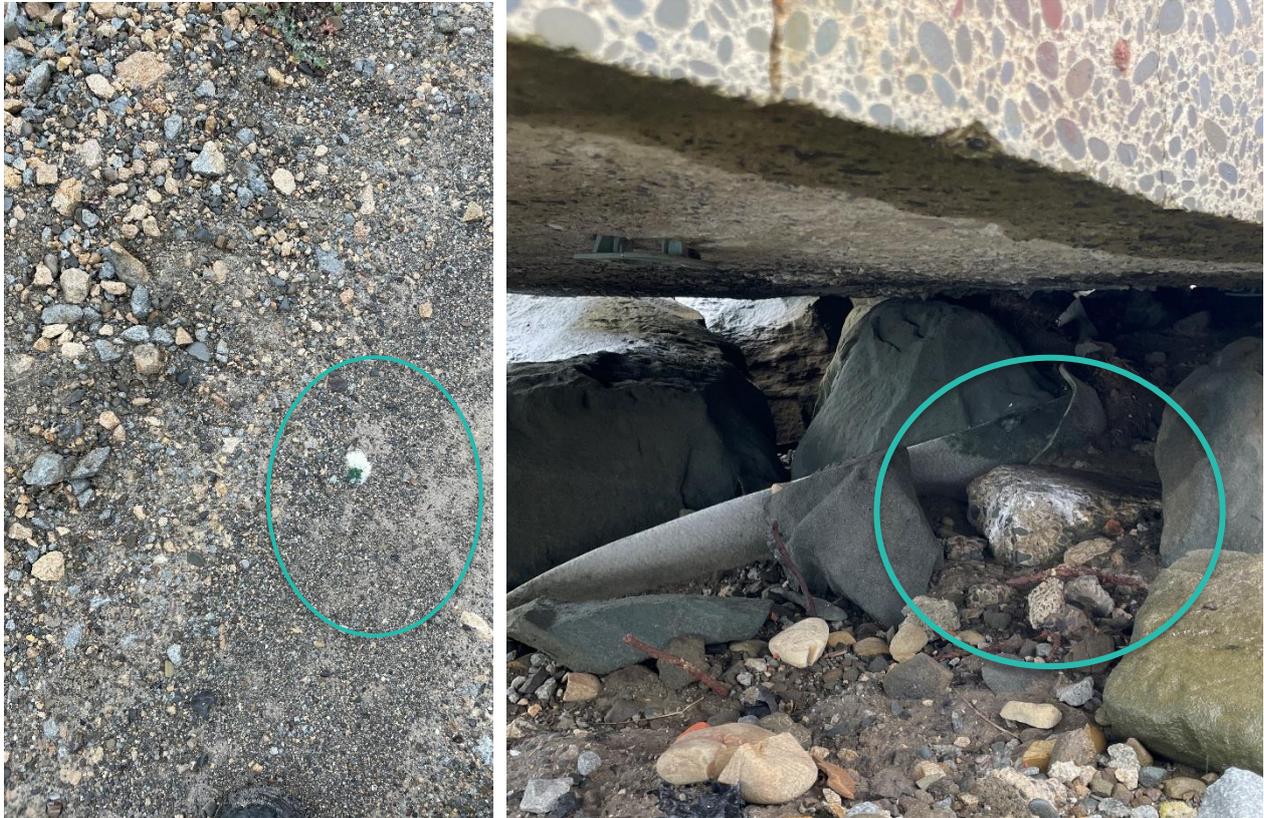
Figure 15: Incidental observations of fresh kororā signs (guano) along the seawall.

Thirteen dog detections of kororā were recorded in the Enhancement Area section during the November 2021 survey (Simm, 2021). This area is not affected by the TBP. During the 4Sight July 2022 site visit, incidental observations of kororā confirmed positive signs along this section (Figure 15). The Southern Log Yard Seawall Enhancement Area section of the seawall is more sheltered from waves due to the presence of the Kaiti reef (Figure 13). This enhances its potential for kororā access and use. The habitat value has been increased by the recent reinstatement of the rock wall with crevices suitable for kororā along with the associated conservation efforts (predator control, planting and nest boxes) by Ecoworks and Eastland Port.

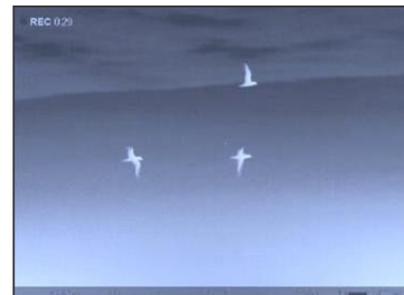
Fig 15: A group of pre-breeding grey-faced petrel (*Pterodroma macroptera*) at Young Nicks Head, Gisborne, July 2021. Observations made using a thermal camera allow us to estimate number of individuals present which is otherwise impossible with fast flying nocturnal procellariiformes.

Another option which allows for excellent observation of pelagic seabirds is to use thermal imagery. This has been used by Ecoworks NZ at a number of sites within Tairāwhiti and in Hawaii and has been an effective tool to record grey-faced petrel, sooty shearwater, blue penguin and kiwi activity at remote sights and when no moon is present.

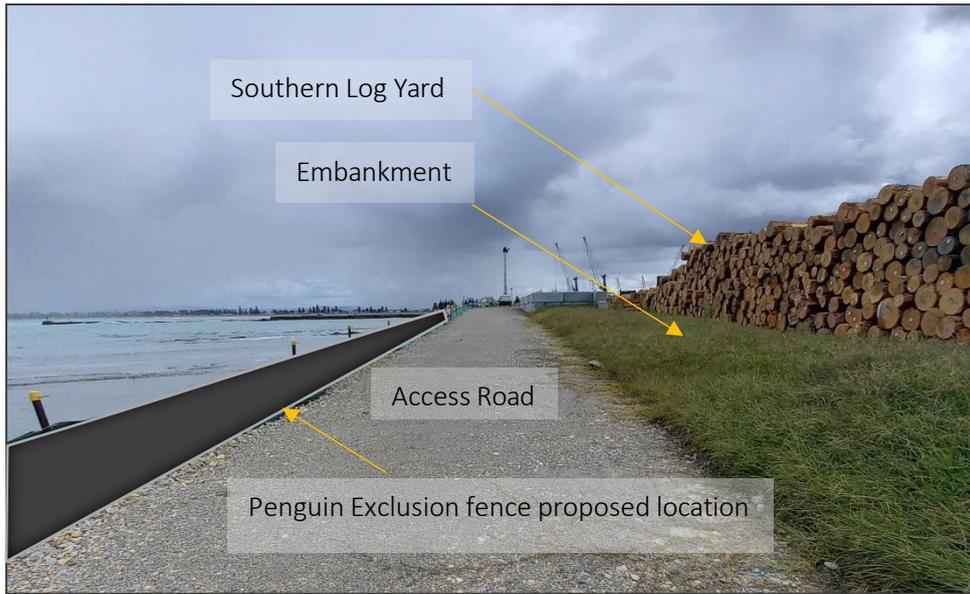
Fig 17: Penguin exclusion fence proposed line at Eastland Port.

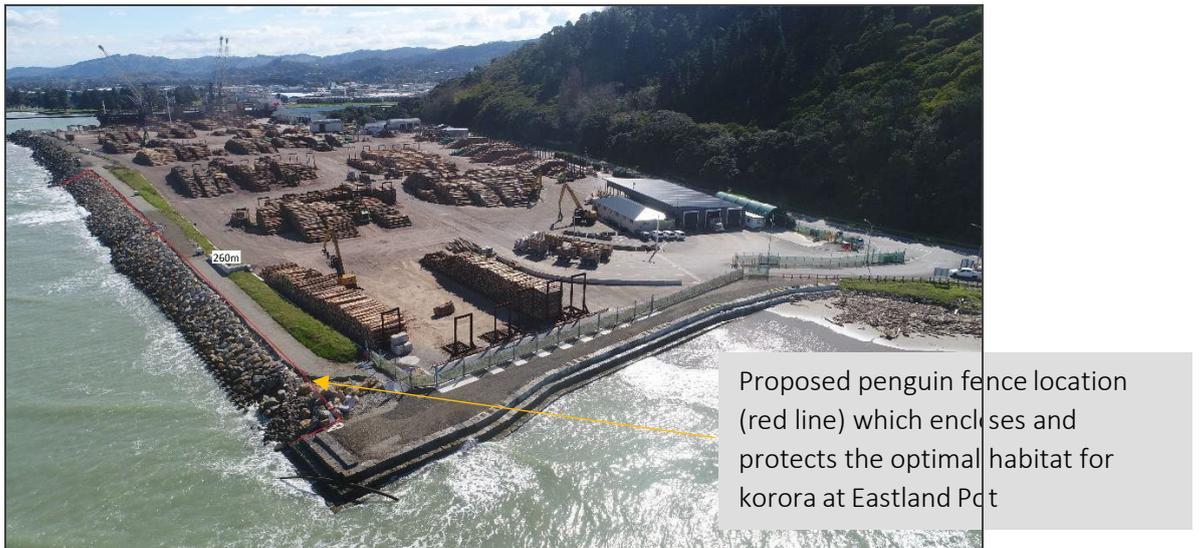
Fig 18: Aerial view of the Southern log yard revetment wall and proposed location of the penguin fence.

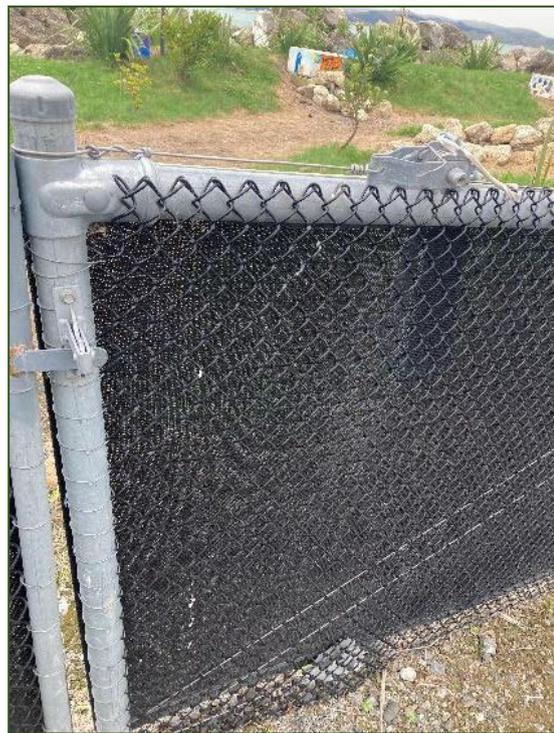
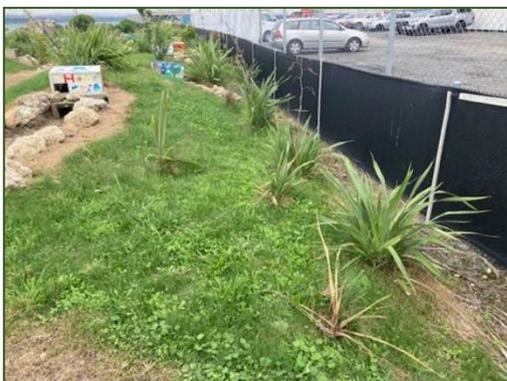
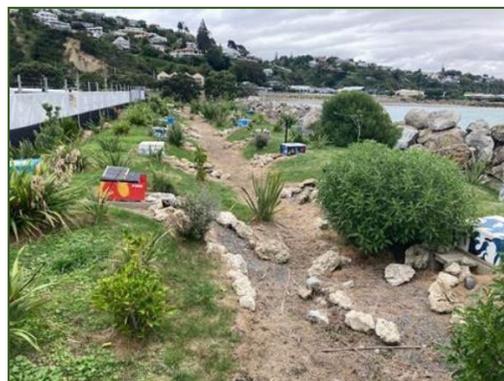
Figs 19-20: Napier Port colony site showing the penguin fence which prevents kororā exiting the colony and entering vehicle access areas (Photos Supplied – Paul Rose, Napier Port)

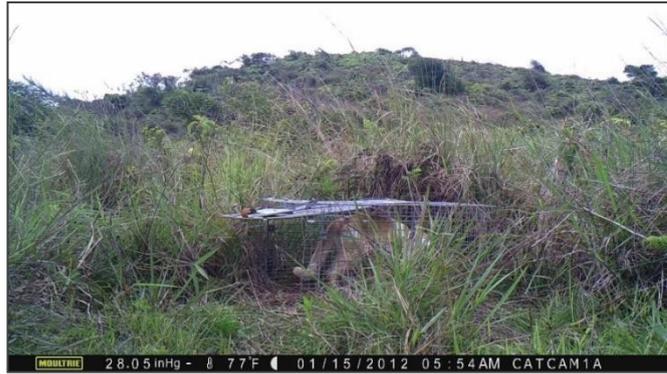
Steve Allen (SA) Trap

Traps are set at the top of a wooden ramp. The ramp is an 800mm length of 150 x 25mm H3 radiata. It runs at a 5-10° angle and extends from the tree with the lower end bugle screwed into the top of a 50 x 50mm tanalised wooden fence batten driven into the ground to a depth of 200mm (Refer photo attached).

Fig 24: A correctly positioned raised feral cat set.

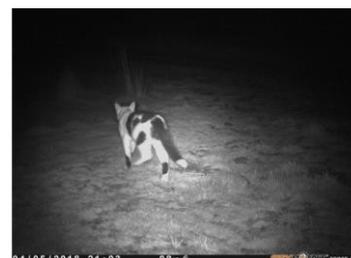
Figs 25-26: Camera traps at Cape Sanctuary and James Camerons Project, Wairarapa detecting feral cats.

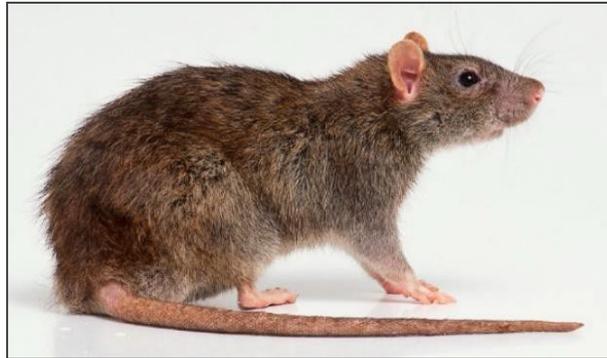
They have small ears which hardly reach the eyes if pulled forward, the blunt nose profile and the thick tail which is less than the length of the rats body.

Fig 27: Norway rat –small ears, blunt nose, thick tail, a burrowing rat species.

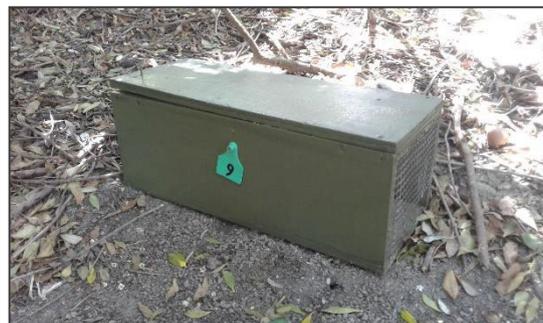
The trap set is a wooden tunnel 600mm in length (800mm in weka areas). It is constructed of treated H3 radiata pine. Both 200 x 25mm for the walls and 250 x 25mm rough sawn H3 for the base. The box is screwed together using #2 square drive screws. The lid is made of 17mm plywood and cut 600 x 250mm. A warning sign must be stencilled on the lid with spray paint and in high visitor areas the trap boxes must be painted and presented to a high standard.

A plastic triangular track marker or cattle ear tag must also be screwed to the lid with the trap number on it (above). Cattle tags can be ordered from PGG Wrightsons with the printed number or code required for your traps. The 17mm ply trap box lid is screwed at diagonally opposite corners with a square drive 40mm stainless steel screw to prevent access to anyone other than the trapper. Treated ply is preferred as it does not buckle over time.

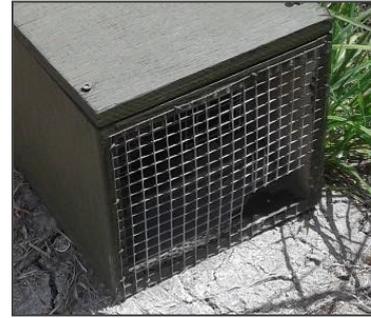
Netting Hole Size

In areas where ground nesting species such as kororā are present a double mesh screen is key. These screens also help direct mustelid's onto the 'trip plate'. Twelve- millimetre aviary mesh is stapled to each end of the tunnel using small fence batten staples and another screen is set 150mm inside the tunnel with a second mesh screen. An entrance hole is cut at the bottom corner of the outside screen (right), 5 x 5 squares in size. The inside mesh has a hole 5 x 5 squares also cut into the centre but positioned 3-4 rows high so that mustelids climb through the hole and land directly onto either the fenn or doc200 plate. I would recommend a slightly larger hole size at this site to allow easy access for ferret. It will be impossible for a kororā to access a double mesh screened trap set. An entrance hole aprox 75 x 75mm will allow access to all mustelids (including ferrets) and keep out protected wildlife.

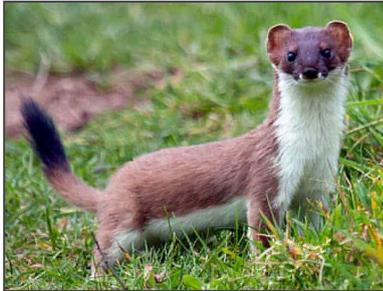
Stoat (black tail tip)

Ferret

Stoats are the next size down, they are chestnut brown with a white-crème belly and have a bushy tail with a black tip. The white belly fur forms a smooth lateral line along the body. Weasels are the smallest mustelid to be introduced to New Zealand they are similar to a stoat but have several discerning features. They are smaller than stoats, the cream-coloured belly fur forms an irregular lateral line along the body, and a weasel does not have a black bushy tail. The ears are also smaller and more rounded in proportion to the head

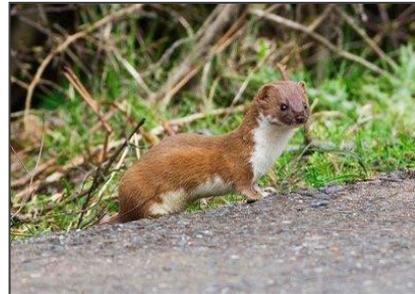
Weasel

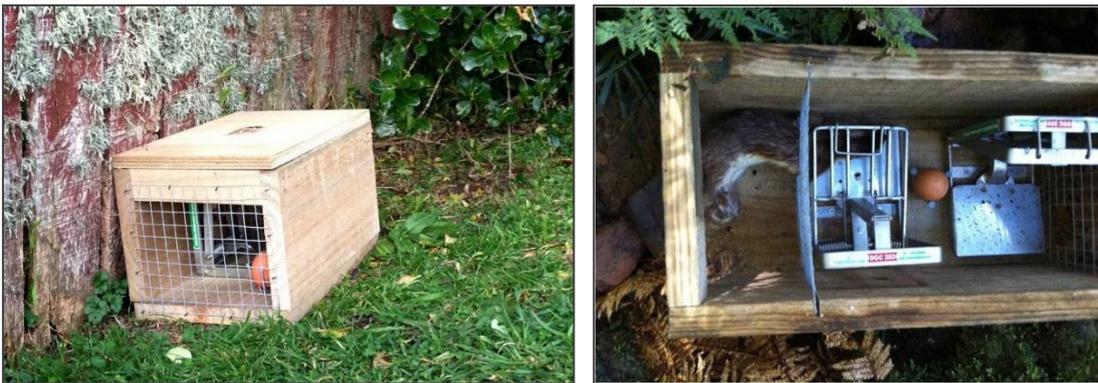
Figs 39-40: Two options using DOC200 sets, the single set box and the double set at right with mesh holes cut to direct the target species onto the trap plate. We believe that single set DOC200's catch less than double set traps (*Photo Courtesy of DOC*).

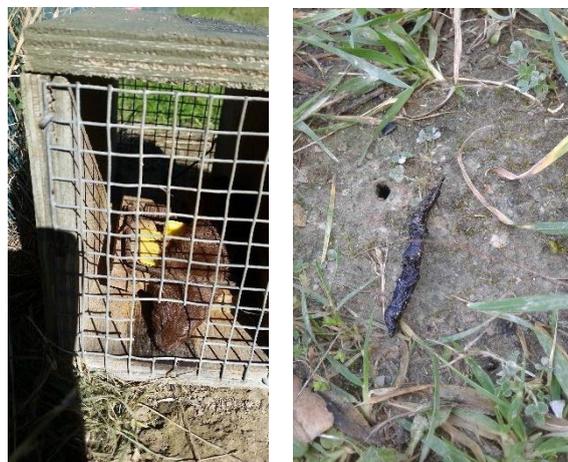
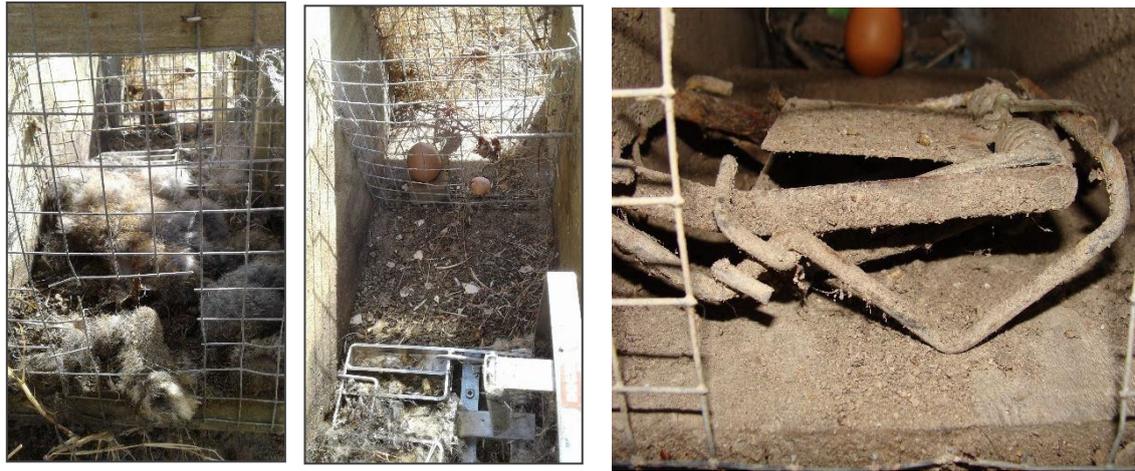
As a trapper it is vital to look for sign of predators while on the job. The far-right photo is a stoat scat (faeces). Approx 7 mm wide by 50mm long and jet black. Rat fur is usually present. Hedgehog scat is similar but does not contain rodent fur.

Predator trapping is the foundation of most species protection projects in Aotearoa. The examples above show how a trap should not be set. These traps are not at all effective, will not catch mustelids and therefore a waste of time, labour and resources. Even though the trapper has visited recently (fresh eggs!) no trap maintenance has been done.

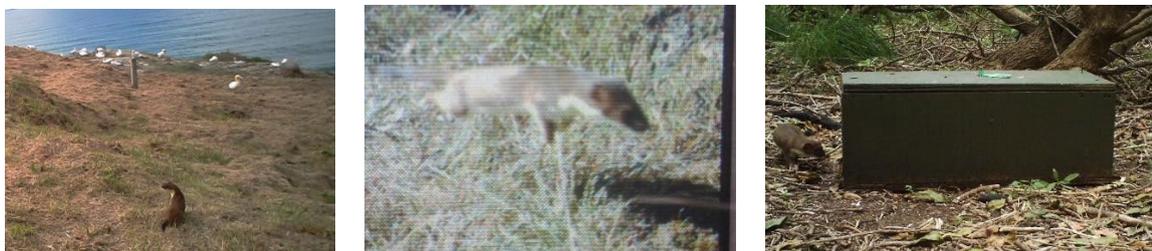
Figs 46-48: Cameras are a great tool to monitor mustelid activity. In this case stoats.

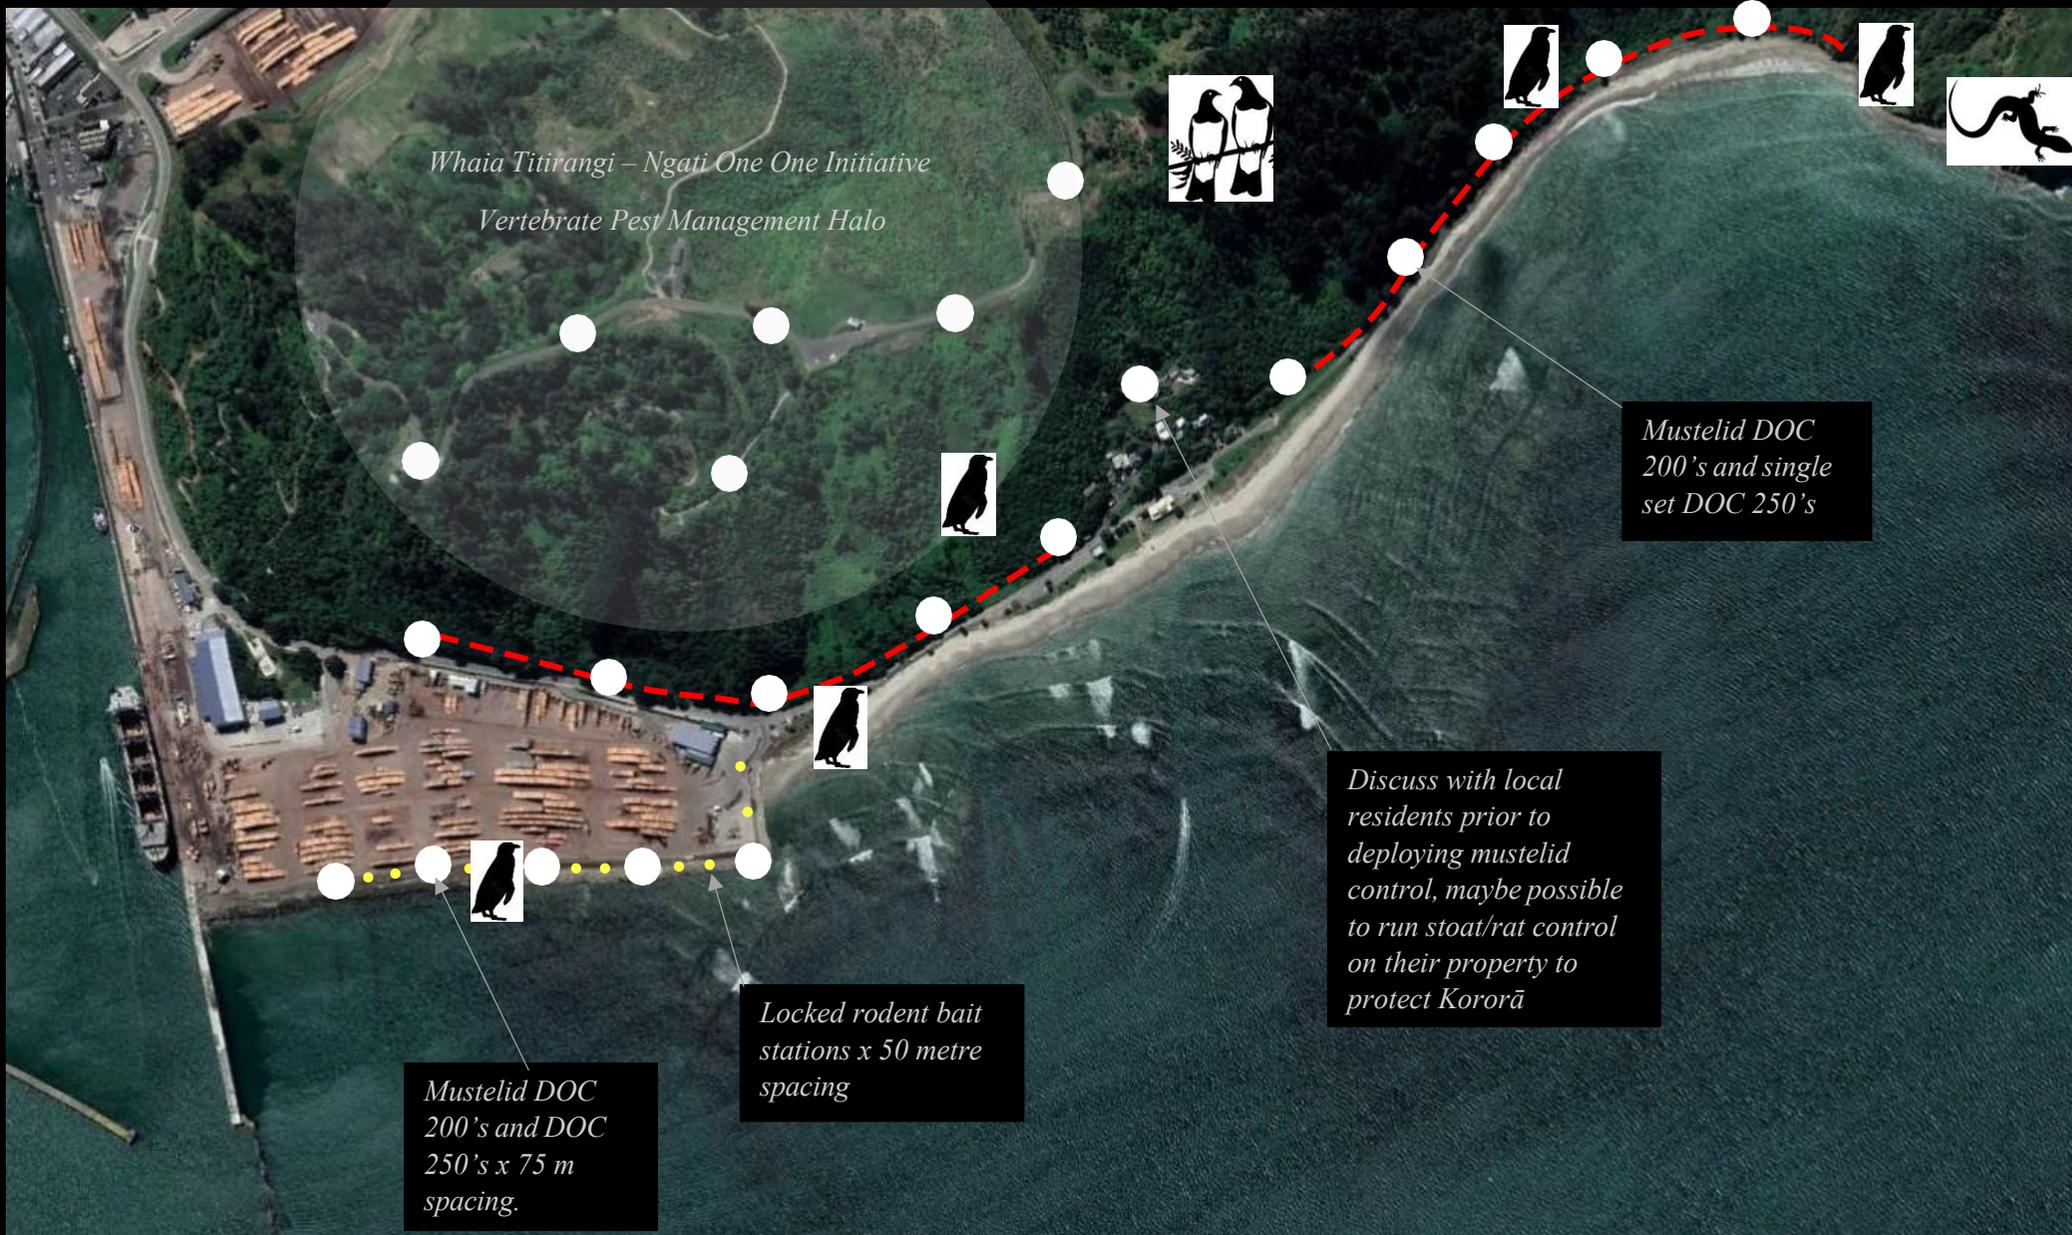
Predator Control Layout – Ferret, Stoat, Weasel and Rat Control

Target Pest Species	Control Method Options	Control or Outcome Target
Mustelids – ferret, stoat and weasel.	DOC 200 and Fenn No.6 Double sets at 200m spacing.	100% survival of juvenile & Adult Kororā at EPL/Onepoto.
Feral Cat	Cage Trap or Steve Allan trap.	100% survival of juvenile & Adult Kororā at EPL/Onepoto.
Ship and Norway rat	Ground based toxin application and Victor Pro snap traps within target areas.	Bi-annual tracking tunnel indexing target rate of <2.5% RTI.

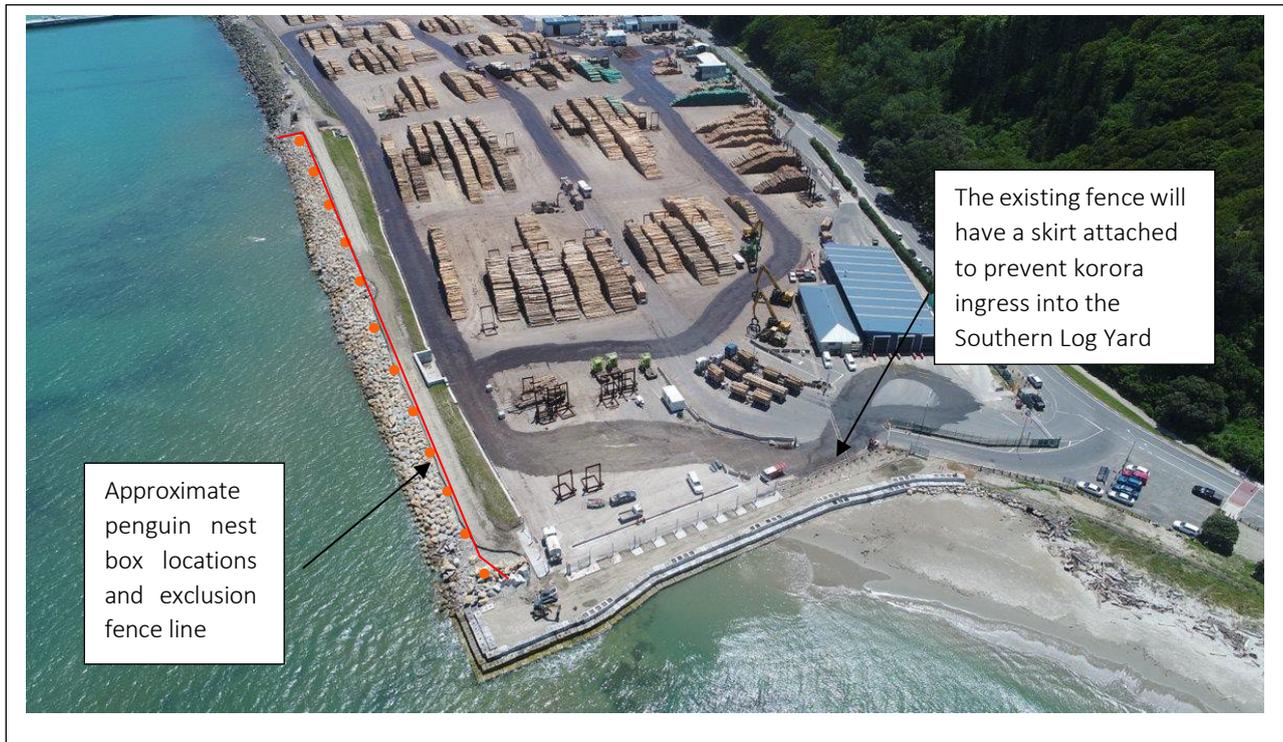
Fig 52: General nest box locations above EPL revetment (Photo Supplied -EPL).

Approximately 1200-1500 mm will be available between the upper boulders of the revetment wall and the kororā exclusion fence. This will allow ample space to deploy the 400 x 500 mm nest boxes with their corresponding stone/rock protection. There are no guarantees that kororā will readily use these artificial nest boxes and may prefer the rock wall, however we hope over time these will become well used as we have seen at various other locations and will therefore allow the Ngati One One teams to monitor breeding success and the survival of kororā easily at this EPL site.

The base course under each nest box will be 75 mm higher than the surrounding ground level and include a free draining fine pea metal over the existing 40-60mm base course. This will then have a 75 mm soil layer and nest material added within each box.

The exterior of each nest box will be layered with 60-100 mm diameter rock cobble which will be mounded around and over each nest box to provide heat protection particularly from the Gisborne summer heat and allow air flow.

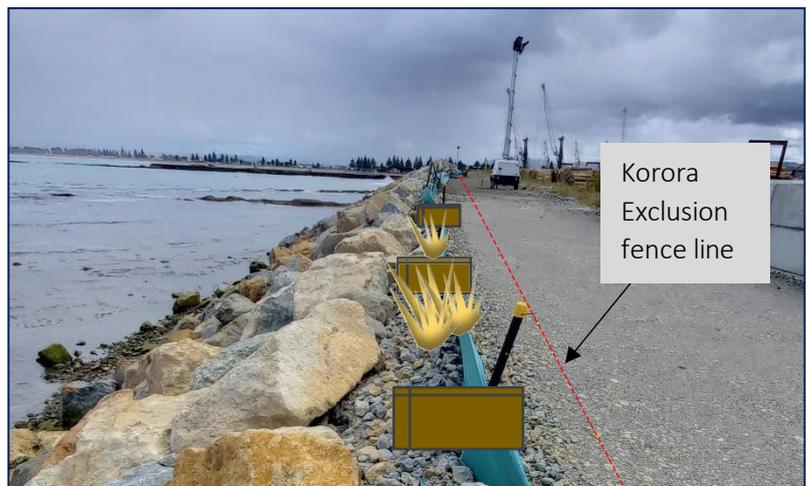
As seen here in Figure 54: the temporary shade netting fence will be removed. The new penguin exclusion fence will be positioned 1.0 metres closer to the centre of the existing access way allowing space to install the foundations and the kororā nest boxes themselves.

An excavator will be provided to supply the appropriate rock, sand and shingle to establish these nest box sites and re-locate any boulders if required to provide additional space for each nest box. A sand tussock or similar low growing coastal plant species will

also be situated between nest boxes to both improve the aesthetics of the site and to provide additional summer shade cover for visiting kororā.
