Eastland Port Twin Berths Project Little Penguin/ Kororā (*Eudyptula minor*) Assessment of Ecological Effects

For Eastland Port

August 2022

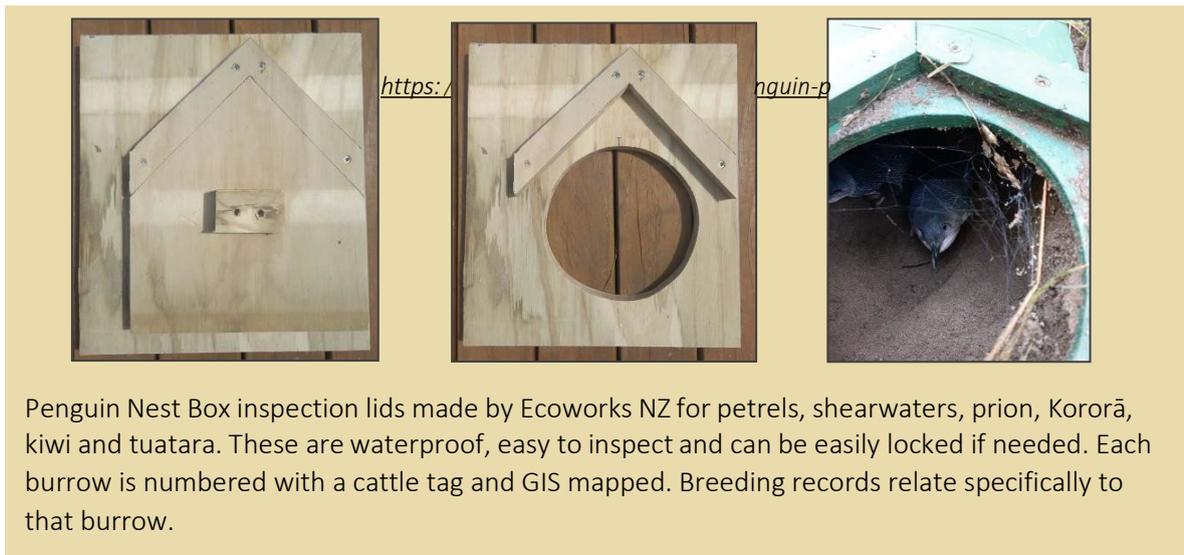
Penguin Nest Box Measurements

Penguin Nest Box inspection lids made by Ecoworks NZ for petrels, shearwaters, prion, Kororā, kiwi and tuatara. These are waterproof, easy to inspect and can be easily locked if needed. Each burrow is numbered with a cattle tag and GIS mapped. Breeding records relate specifically to that burrow.
