Our Reference: P-001538  
31 July 2025

## Geotechnical Addendum Report Te Ara Tipuna Trail – Revised Track Layout – Rev B

June 2023  
Initia Ref: P-001538 Rev 2  
Te Ara Tipuna Trail – Gisborne to Opotiki  
INITIA

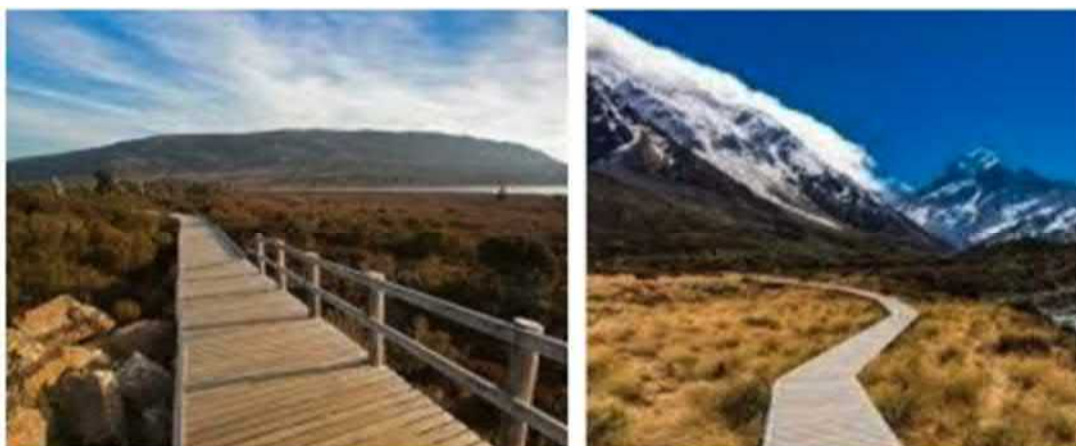
Figure 1-3: Example image of a proposed raised boardwalk tier track.

The track is a high quality raised wooden walkway, similar to that constructed between Waikanae and Midway Beach in Gisborne. The wooden walkway is likely to be supported on timber poles embedded approximately 300 – 500 mm below ground level. Figure 1-3 and Figure 1-4 below provides examples and a cross section of the proposed raised boardwalk track.

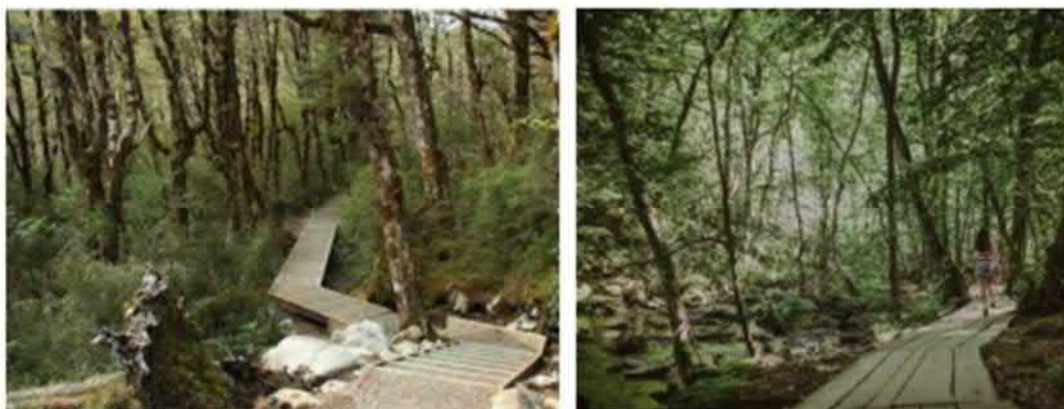
Figure 1-5: Example image of a proposed boardwalk tier track.

This track is a wooden walkway that bears directly on the ground (i.e. is not raised). This type of track will not be as significant and visually appealing compared to a raised boardwalk track and may have some grassed sections. Figure 1-5 and Figure 1-6 below provide examples and a cross section of a proposed boardwalk tier track.

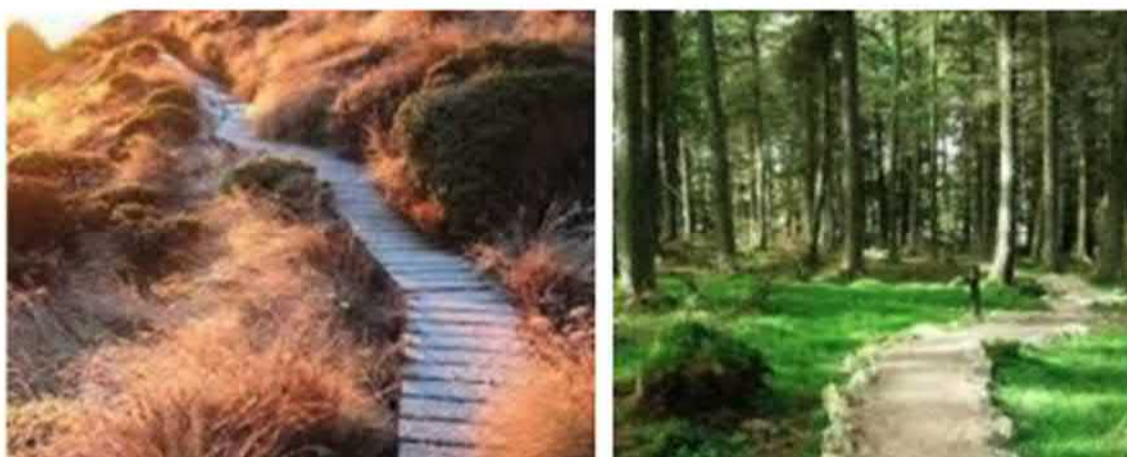
Figure 1-7: Example image of a proposed gravel tier track.

The gravel tier track will have an aggregate surface (100 mm of compacted aggregate) which is crowned in the middle walkway. The gravel track will provide a higher level of service than a farmland or beach track. Figure 1-7 and Figure 1-8 below provides examples and cross section of a proposed gravel tier track.
