## Te Ara Tipuna Trail

### Transport Safety Assessment and Management Plan

Prepared for Te Ara Tipuna  
Charitable Trust

Revision 7 - July 2025

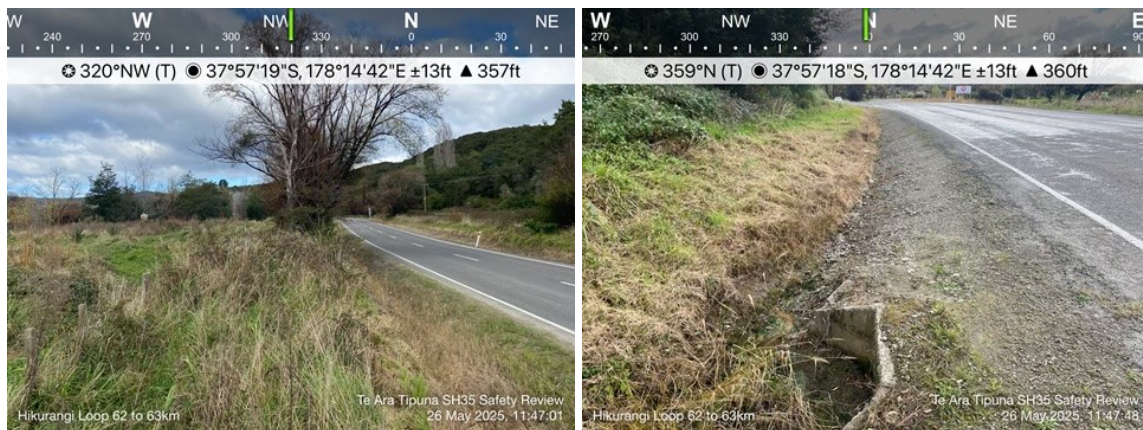
Figure 2.1-1: Location of proposed crossing on SH35 south of Makarika Road (10 km/h speed limit); (looking south-left; looking north-right)

All proposed crossing points will be located at sites that provide at least 165m of forward visibility in both directions on sections of SH35 with a 100 km/h speed limit. All crossing points have been carefully selected or realigned to achieve this requirement. Where this is not naturally available, vegetation clearance, minor regrading, or realignment of the trail or the crossing location will be undertaken. Refer to the following photographs for some examples of proposed crossing locations.

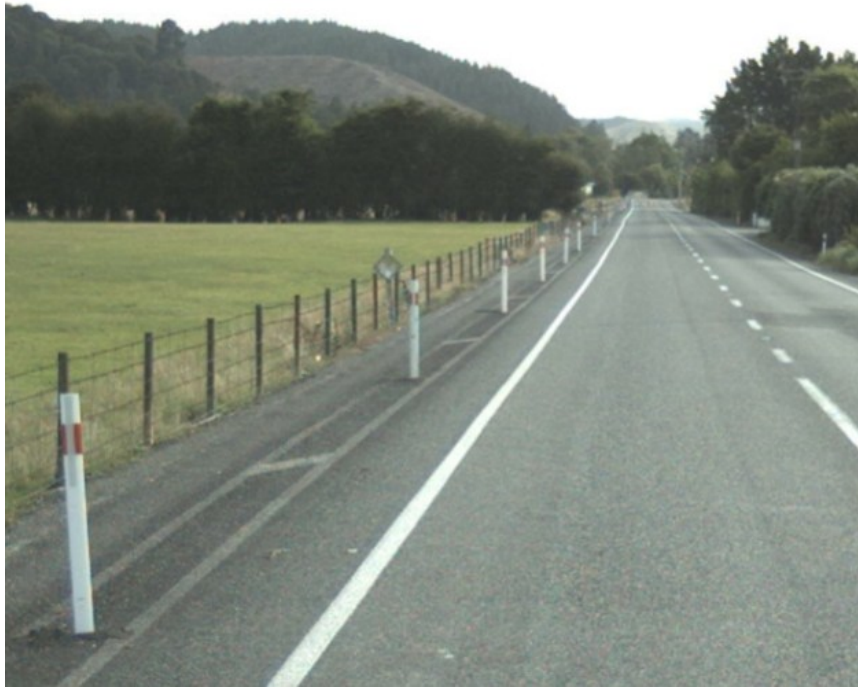
Figure 2.1-4: Example of wide shoulder with delineation for vulnerable users

In constrained locations, such as adjacent to culverts or drainage ditches, the trail may encroach closer to the carriageway. Where this occurs, safe-hit posts or other flexible delineation devices may be installed, particularly on curves or areas with reduced visibility. In extreme circumstances, a roadside guardrail may be installed, where the trail is less than 4m from the live lane, for greater than 50m in length (if less than 50m in length, then flexible delineators can be used) . An example of a similar facility on SH6 in Tasman, with a wide sealed shoulder, is shown in Figure 2.1-4.

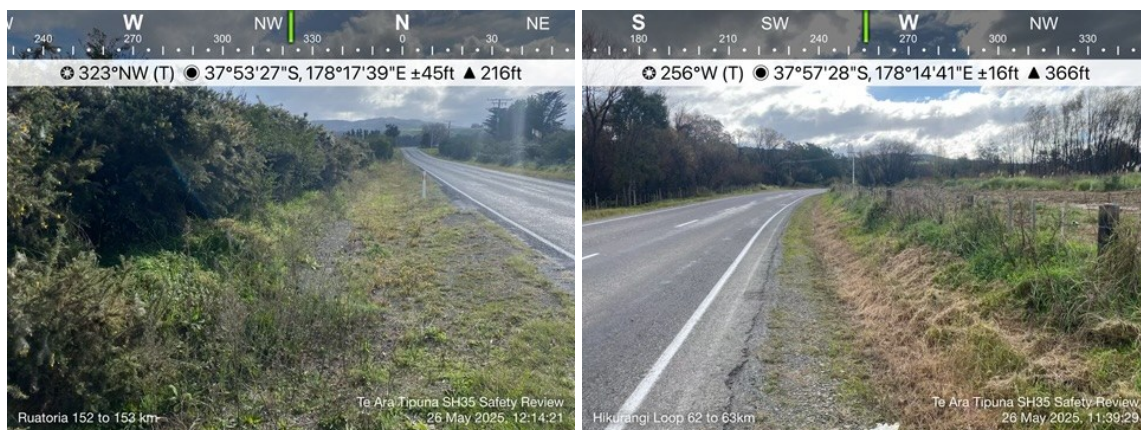
Figure 2.1-5: Typical shoulder width constraints

On short straight sections with sufficient visibility, closer offset distances may be considered acceptable based on a risk assessment and RCA input. Refer to the following photographs for some examples of shoulder width constraints along the corridor.

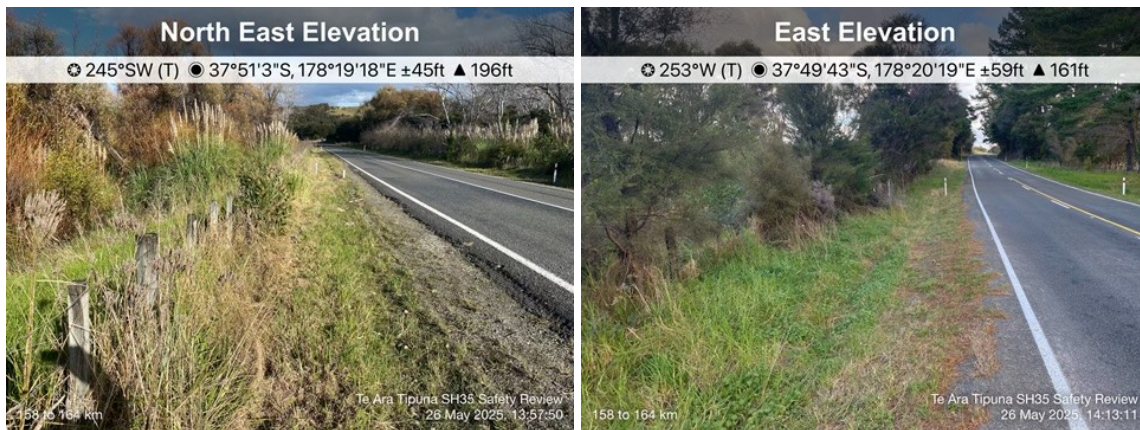
Figure 2.1-6: Typical shoulder and verge width constraints

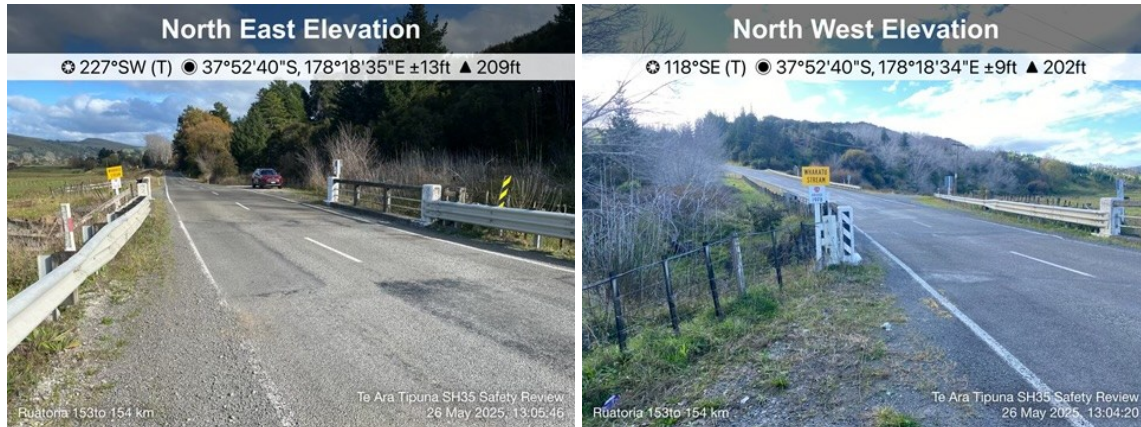
Figure 2.1-7: Location of proposed bridge crossing with good sight distance and short bridge span

distance, additional treatments may include user-activated electronic warning signs or, in select cases, signalised (traffic light) crossing systems. The spreadsheet in Appendix A outlines and recommends the preferred treatment type for each bridge location. Refer to the following photographs for some examples of proposed bridge crossing locations.

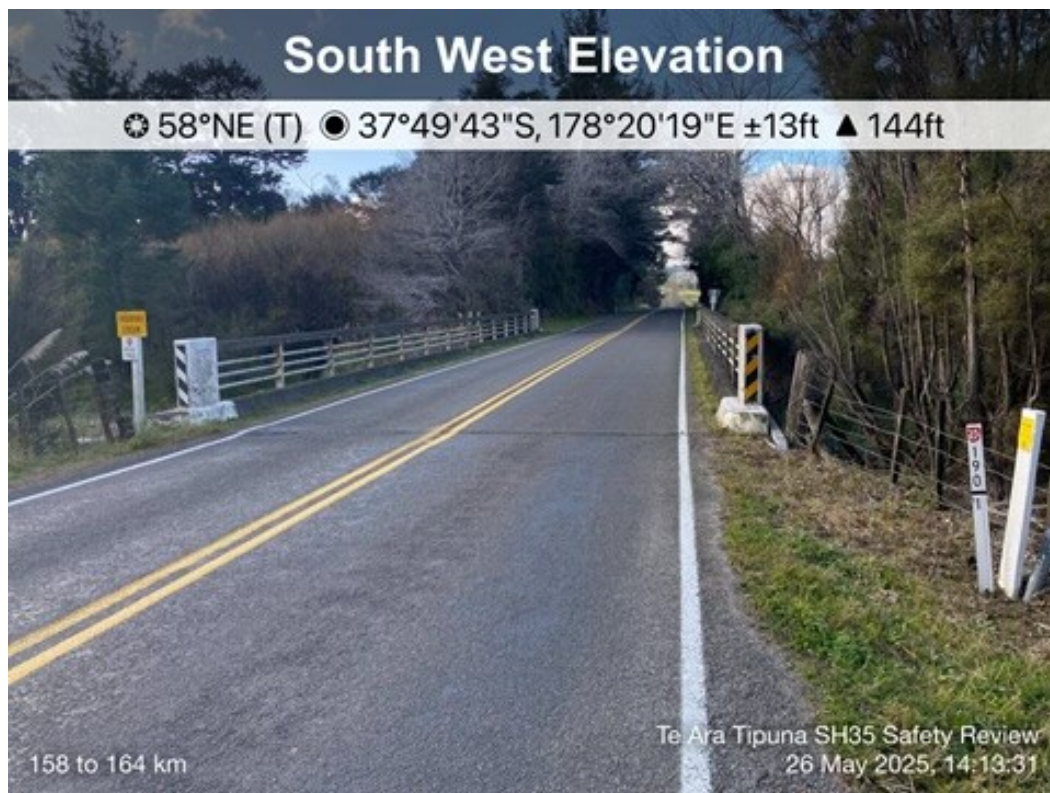
Figure 2.1-8: Location of proposed swing bridge crossing due to longer bridge span

Numerous bridges on SH35 are too narrow to safely accommodate pedestrians. In these locations, separate clip-on structures (or swing bridges) or new pedestrian bridges will be required. Drawings illustrating safe crossing options, including typical cross-sections, signage strategies and alternative treatments, are referenced in Appendix C. The preferred bridge crossing options and their rationale behind the choice is shown in Table 2.1.2 below. This includes local road bridges also.

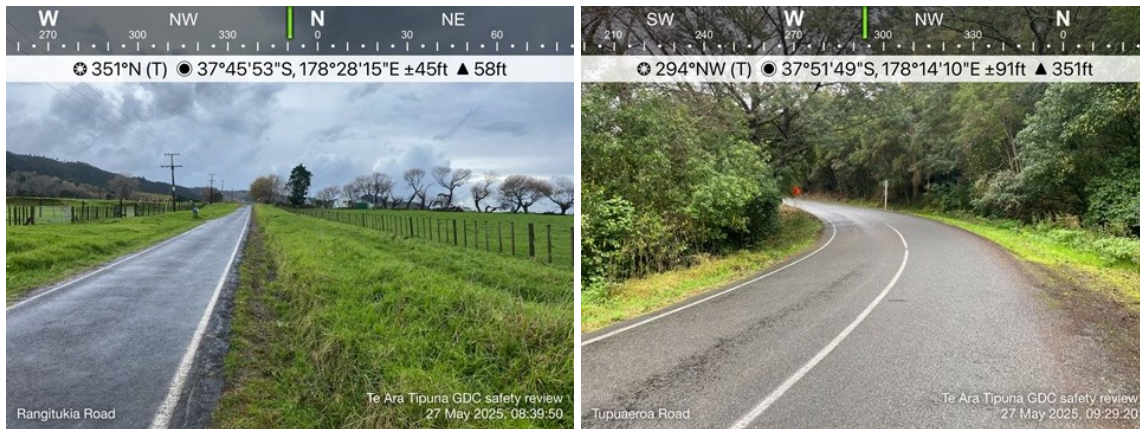
Figure 2.2-1: Typical locations where pedestrians could share with vehicles, or use the wide grass verge

Where necessary, additional mitigation measures, such as selective vegetation clearance, use of the more visible road shoulder, and installation of roadside mirrors at blind spots, can further support safe co-use. This approach aligns with accepted practice for rural walking routes in New Zealand and is consistent with the Safe System philosophy, where operating speeds are low and traffic volumes are minimal. Some examples of this are shown in the following photographs.

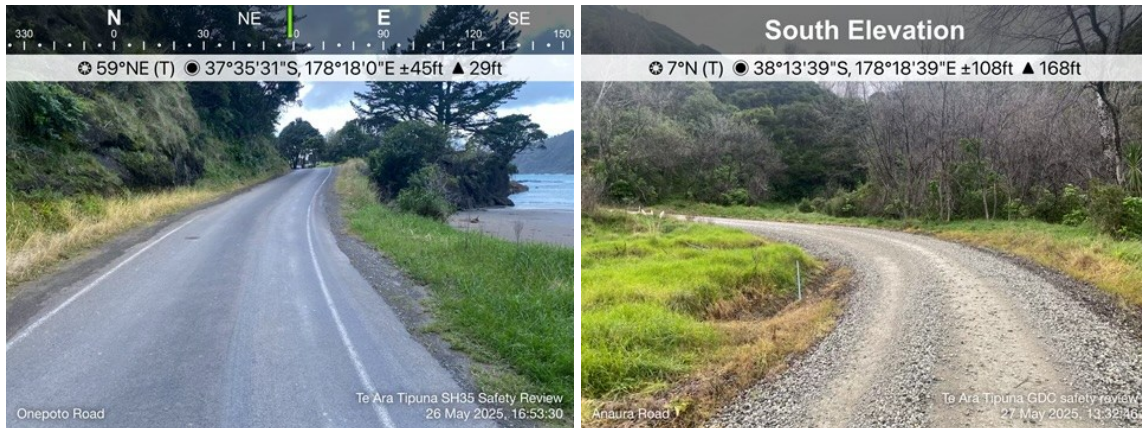
Figure 2.2-2: Typical locations where pedestrians could share with vehicles, on sealed and unsealed sections

Some examples of shared roads are shown in the following photographs.

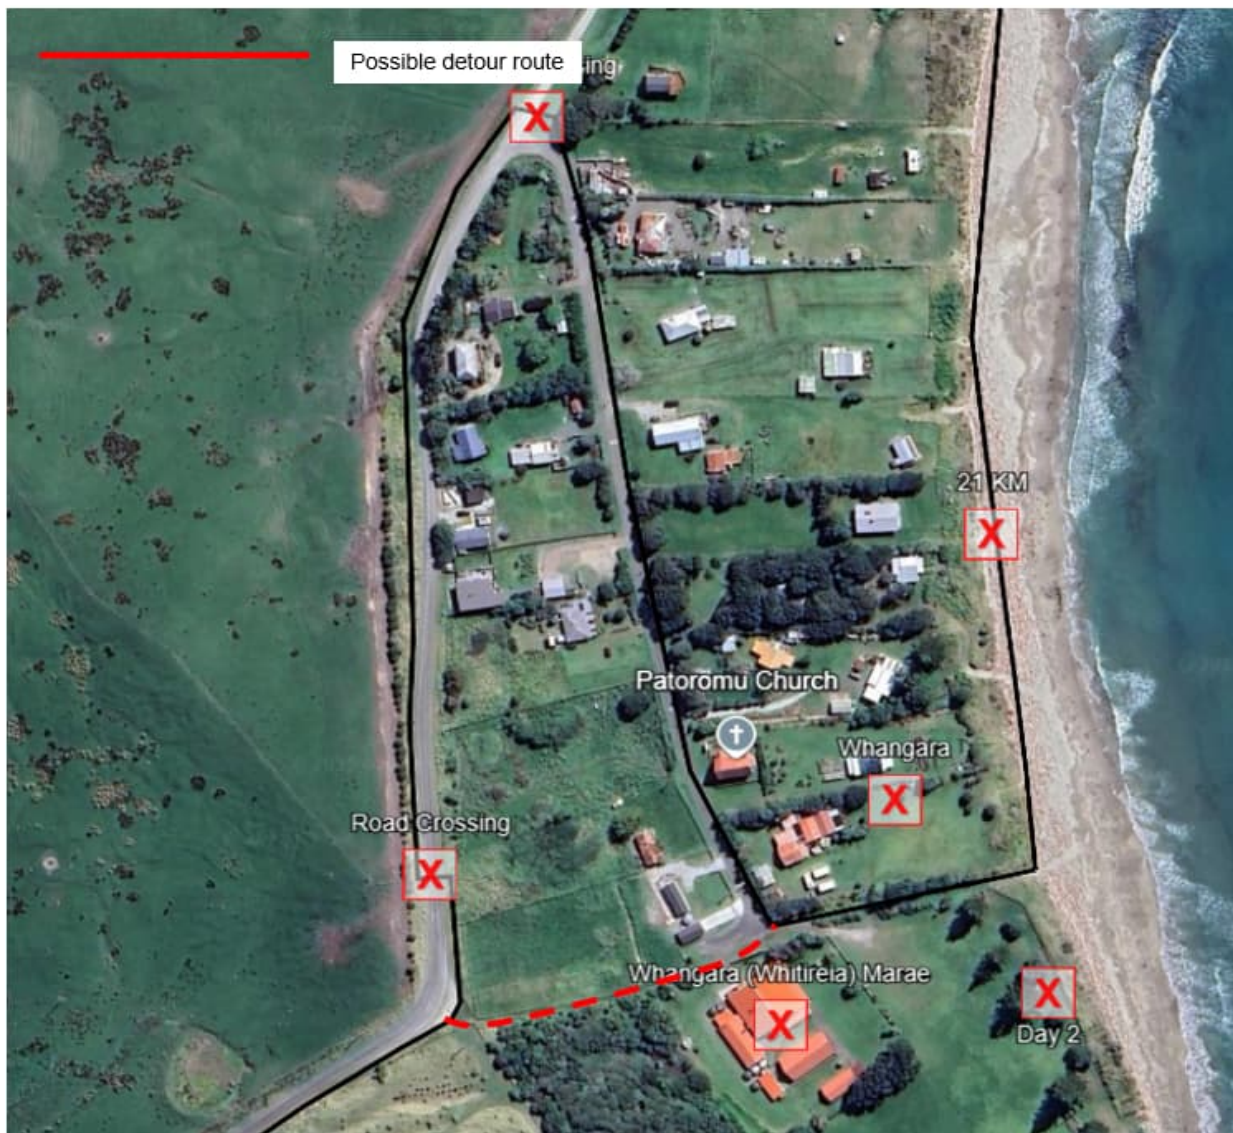
Some foliage/trees will need to be removed/trimmed to ensure the visibility envelope is maintained at all crossing

A typical rural crossing should be designed and provided to GDC as a concept for approval.
